# **Urgent Medical Device Correction**

# Attachment A (Air in Kangaroo Enteral Feed Pump Sets Tubing Check Process)

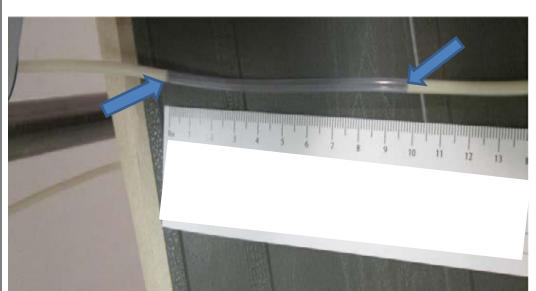
To check the feed set for entry of air in the tubing (see the example below) follow the steps described below.

\*This is an example and the air in the tubing may not be as pronounced as shown in the image.

- Press "Run" on the pump after installing and priming the feeding set.
- After 30 seconds, observe the tubing between the pump and the patient to check for air being drawn into the line.
- It is not uncommon, and not a problem, to see a small amount of air in the feed tubing (approximately 1.3 cm [1/2 inch]) after the pump checks for any blockages.
- Do not use the feeding set if you see a single segment of air measuring greater than 2.5 cm (1 inch).
- Do not use the feeding set if you see several air bubbles that cumulatively measure greater than 2.5 cm (1 inch)

The air in tubing event is found to be intermittent and is not observed in all lots. Thus, if a defective feeding set is identified, it does not necessarily mean that the entire lot is defective.
